Windows Unified Driver User Guide

VeriFone, Inc., <http://www.verifone.com>

Revision 0.1.5

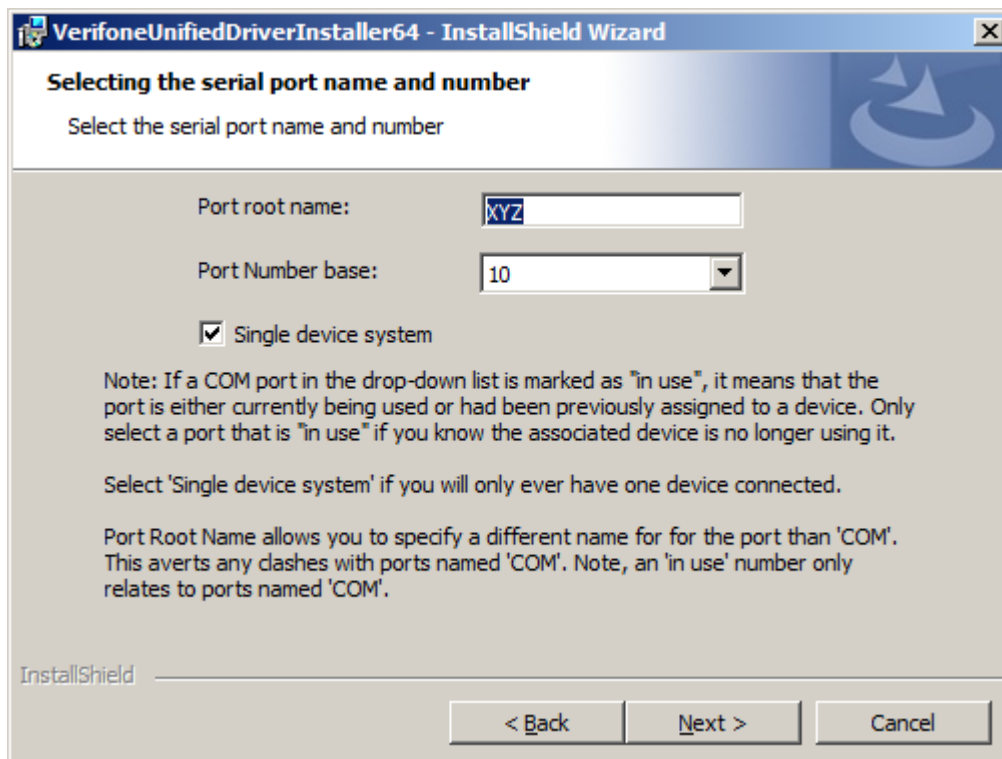
7.1. UI Install

Installation can be silent, or UI driven. If it is silent, then the requisite information must be specified in a batch file.

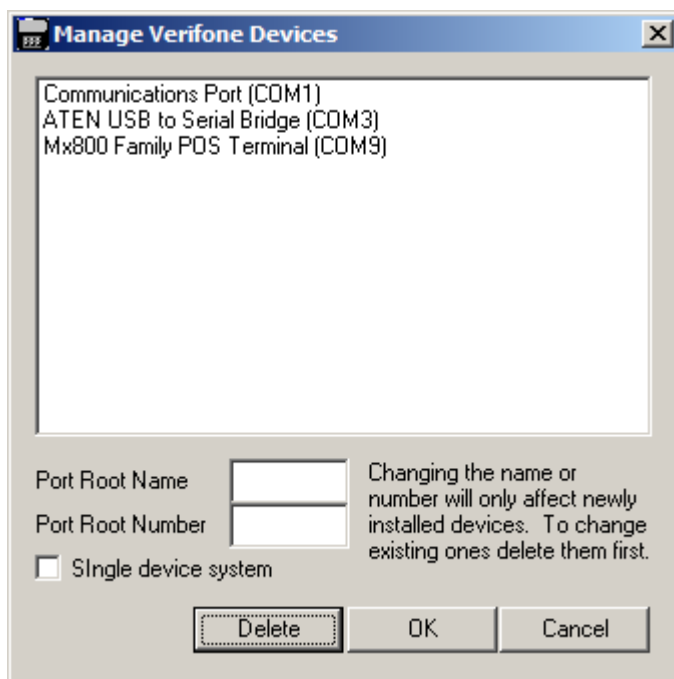
Run Verifone Device Manager

This shows all the communication ports on the machine, whether the devices are connected or not.

Selecting one of them, and clicking Delete, removes that device from the system. If it is a Verifone device the number it is using is liberated and will be reused by any new devices installed.

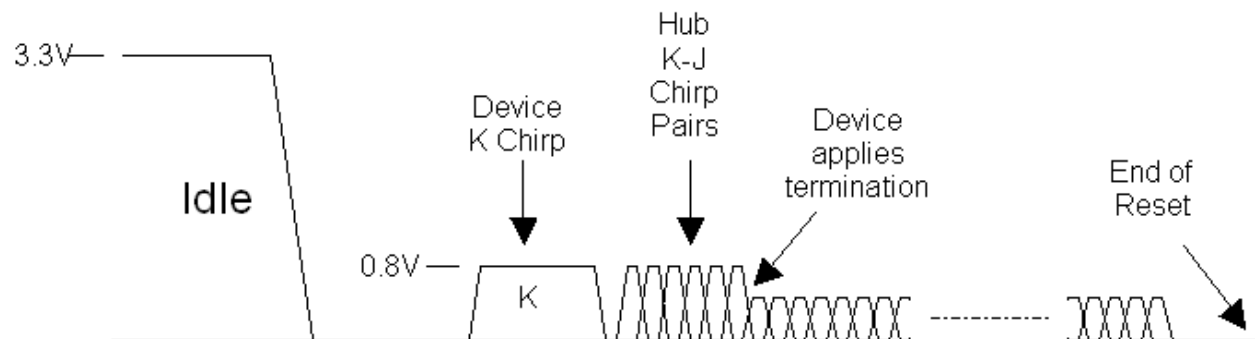
When a USB device is inserted into a host, PC for example, it shows up as a Full Speed device because its D+ line is pulled up to 3volts. To indicate it is a High Speed device, during the mandatory Reset, when the host pulls D+ and D- low, the device applies a lower voltage to the D- line for a period of time. This is called a Chirp-K. If the host is High Speed capable, it sees this, and replies with a stream of Chirp-Js and Chirp-Ks (alternating low voltage on D- and D+). The host copies the device in applying a different resistor to the D+ line resulting in a 500 millivolt differential which is High Speed.

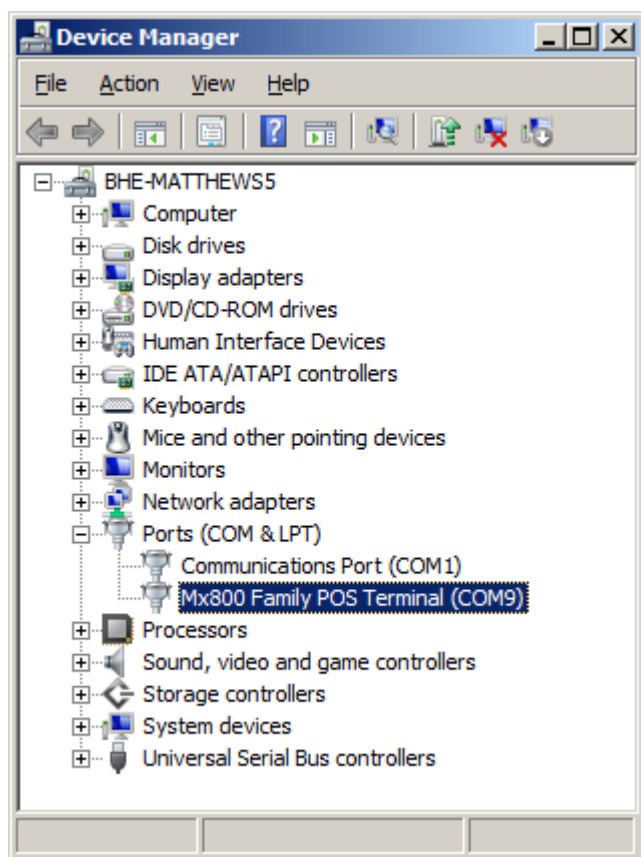
When the system has all this information, and has registered this hardware with the information in the inf file, Devicemanager will look like this:

Depending of course on what device you are using, and what port name and base number was chosen during the install.

At this stage all is good and the application can open that port and begin communicating with the device.

The inf file contains an entry for this hardware ID combination, an associated friendly name for the device, which gets used in place of 'Verifone Mx Gadget v2.4', and an associated service, which is the driver itself.
