ENERGY AND ACCESSIBILITY REFURBISHMENT OF THE PUBLIC RENTAL HOUSING POOL

8. NZEB 2020-2050 REFURBISHMENT MASTER PLAN

8.1. Dashboard Indicators

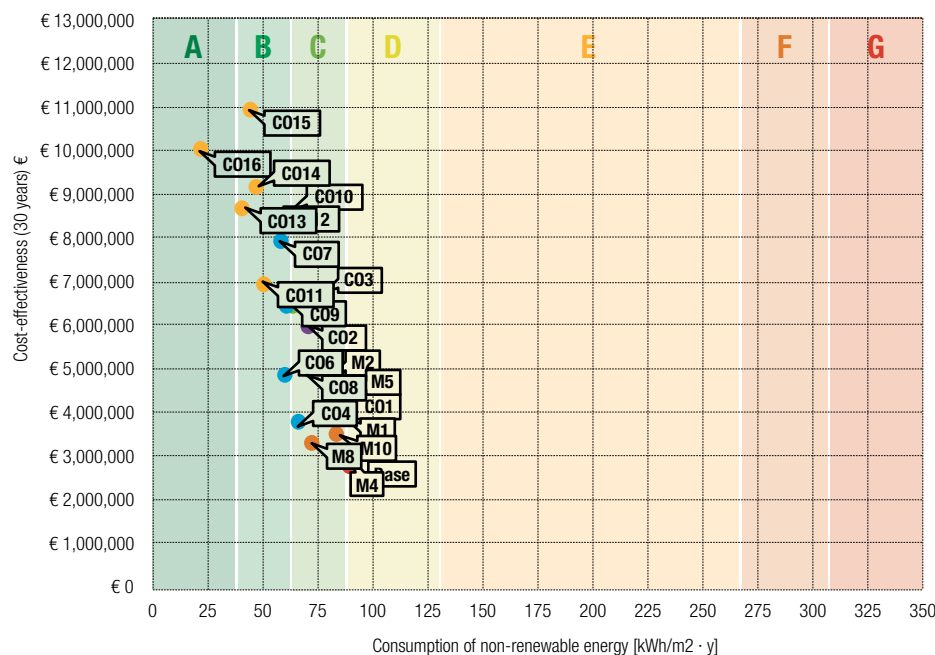
Result of the cost-effective analysis with true consumptions

- **Verification with true energy consumptions:** as explained earlier, the **results of the cost-effective method need to be checked** against the building's true energy consumptions, as the user profile of the tenants of this kind of housing means that the true energy consumption is very different to the CEE's theoretical energy consumption used in the cost-effective calculation.

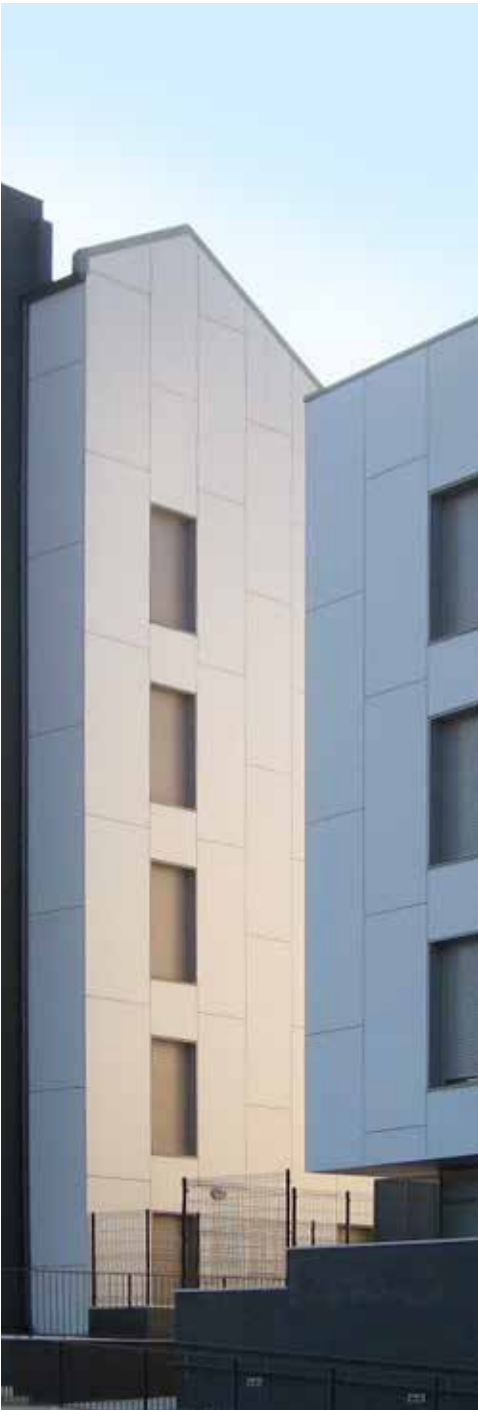
This case involves the following refurbishment scenarios:

- **BAU:** CO9 refurbishment measure, which means the full replacement of the thermal envelope and the renewal of the technical heating and hot water systems.
- **HEB:** CO13 refurbishment measure, which means installing photovoltaic panels, the full replacement of the thermal envelope, and the replacement of existing technical systems by an aerothermal heat pump arrangement.
- **nZEB:** CO16 refurbishment measure, which is the same as CO13, but includes the installation of mechanical ventilation systems in each housing unit.

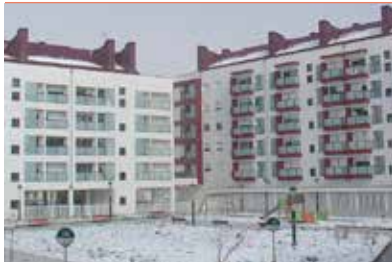
ALO-A001.3
LAKUA 90 - ARABA

No. homes	90
No. public rental homes	90
Year built	2003
<div><div></div><div></div><div></div><div></div><div></div><div></div><div></div></div> <div>D</div>

CHALL.	Diagnosis	Nature of task	Cost
1	4	Full thermal envelope, heat pump and PV.	€ 2,304,000
2	2	E-Lagun project, adapting lift accesses, adapting lift cabin, non-slip linoleum flooring, ensuring halls are accessible, sensor-operated lights in entrance, on landings and in stairwell, accessible video intercom, accessible and signed mechanisms, building signage - sign panels.	€ 205,818
3	3	Digitisation of public stock, instructing tenants in the use of energy installations, deployment of technology (CMMS).	€ 19,972

PHYSICAL ACCESSIBILITY: Details with no impact on normal use.

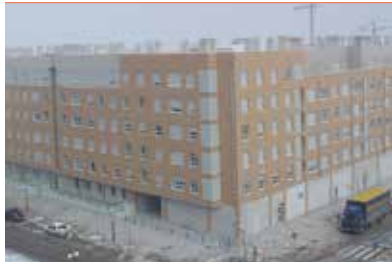
ALO-A002
228 IBAIONDO - ARABA

No. homes	228
No. public rental homes	228
Year built	2004
<div><div></div><div></div><div></div><div></div><div></div><div></div><div></div></div> <div>E</div>

CHALL.	Diagnosis	Nature of task	Cost
1	5	Full thermal envelope, ventilation, heat pump and PV.	€ 7,774,800
2	3	Support for situations of energy poverty-Lagun project, adapting lift accesses, adapting lift cabin, non-slip linoleum flooring, ensuring halls are accessible, sensor-operated lights in entrance, on landings and in stairwell, accessible video intercom, accessible and signed mechanisms, building signage - sign panels.	€ 336,268
3	3	Digitisation of public stock, instructing tenants in the use of energy installations, deployment of technology (CMMS).	€ 35,990

FACADE: Numerous issues in the past (damp and flaking, dislodged bricks, leaks in garage, linked property).

PHYSICAL ACCESSIBILITY: Width of leaf on main door < 90 cm. Some unevenness on main access to entrance.

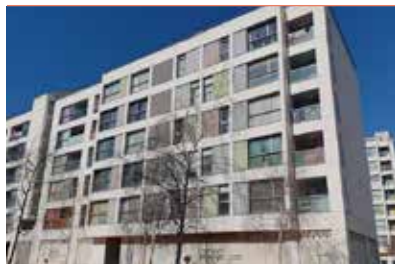
ALO-A003
SALBURUA 84A - ARABA

No. homes	84
		No. public rental homes	84
		Year built	2006

ROOF: Sloping. Issues in the past (leaks). Resolved.

TYPE OF HEATING AND HOT WATER: Communal heating with AUGÉ self-management. Insulation on recirculation ring repaired, but it is hot on the landing where these pipes run.

PHYSICAL ACCESSIBILITY: Width of passage through main access < 90 cm, although the door-leaf is 90 cm or more.

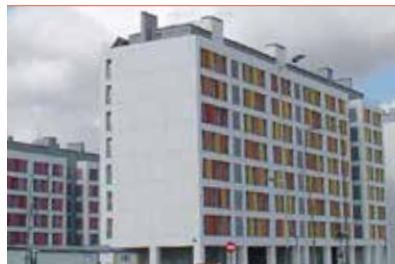
ALO-A004
SALBURUA 84B - ARABA

No. homes	84
		No. public rental homes	84
		Year built	2006

ROOF: Sloping. Issues in the past (leaks). Resolved.

TYPE OF HEATING AND HOT WATER: Communal heating with AUGÉ self-management. Insulation on recirculation ring repaired, but it is hot on the landing where these pipes run.

PHYSICAL ACCESSIBILITY: Details with no impact on normal use.

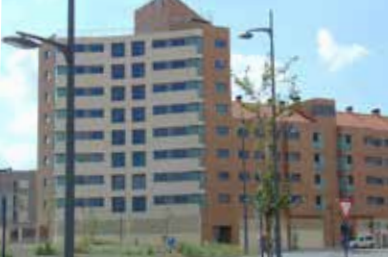
ALO-A007
ZABALGANA 40A - ARABA

No. homes	40
		No. public rental homes	40
		Year built	2006

FACADE: Issues in the past (leaks and detachments), but they appear to have been resolved.

TYPE OF HEATING AND HOT WATER: Communal without AUGÉ. LEAKO System. The installation was renovated, the horizontal manifolds were removed. Issues in the past (change boiler), but they appear to have been resolved.

PHYSICAL ACCESSIBILITY: Width of passage through main access < 90 cm, although the door-leaf is 90 cm or more.

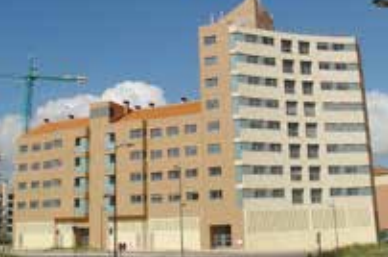
ALO-A008
ZABALGANA 40B - ARABA

No. homes	40
		No. public rental homes	40
		Year built	2006

ROOF: Sloping. Issues in the past (leaks). Resolved.

FACADE: Issues in the past (leaks and detachments), but they appear to have been resolved.

TYPE OF HEATING AND HOT WATER: Communal heating without AUGÉ. LEAKO System.

PHYSICAL ACCESSIBILITY: Width of passage through main access < 90 cm, although the door-leaf is 90 cm or more.

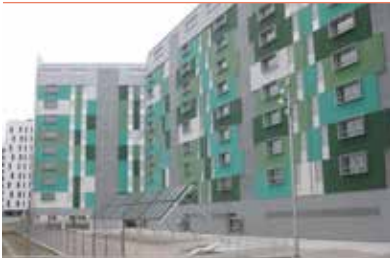
ALO-A017
ZABALGANA 156 - ARABA

No. homes	156	
	No. public rental homes	156	
	Year built	2010

ROOF: Sloping. Issues in the past (leaks). Resolved.

FACADE: With issues (leaks in garages).

PHYSICAL ACCESSIBILITY: Width of passage through main access < 90 cm, although the door-leaf is 90 cm or more.

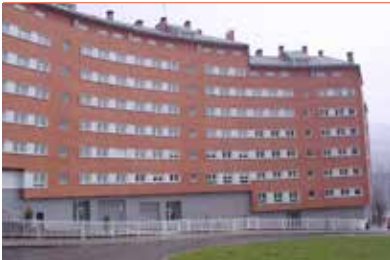
ALO-B002
MINA DEL MORRO 84 - BIZKAIA

No. homes	84
		No. public rental homes	84
		Year built	2005

FACADE: With issues (cracks, detachment of bricks and tiles, badly insulated).

PHYSICAL ACCESSIBILITY: Width of leaf on main door < 90 cm. Some unevenness on main access to entrance.

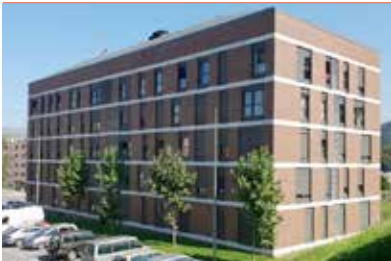
ALO-B008
MUSKIZ 80 - BIZKAIA

No. homes	80
		No. public rental homes	40
		Year built	2010

ROOF: Sloping. Issues in the past (leaks). Resolved.

FACADE: Issues in the past (leaks), but they appear to have been resolved.

TYPE OF HEATING AND HOT WATER: Communal heating without AUGÉ. LEAKO System. Boiler body changed (shared boiler-room).

PHYSICAL ACCESSIBILITY: Details with no impact on normal use.

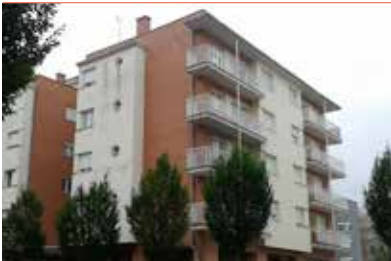
ALO-G002
HERNANI 48 - GIPUZKOA

No. homes		48
	No. public rental homes		48
	Year built		2005

ROOF: Mixed. Issues in the past (leaks). Resolved.

FACADE: With issues (leaks from garden into garages and entrances).

PHYSICAL ACCESSIBILITY: Width of leaf on main door < 90 cm. Some unevenness on main access to entrance.

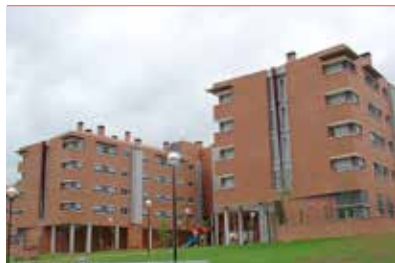
ALO-G004
ANDOAIN 60 - GIPUZKOA

No. homes	60
		No. public rental homes	60
		Year built	2005

ROOF: Sloping. Issues in the past (leaks). Resolved.

FACADE: Issues in the past (leaks, detachments), but they appear to have been resolved. Work performed on one façade.

PHYSICAL ACCESSIBILITY: Details with no impact on normal use.

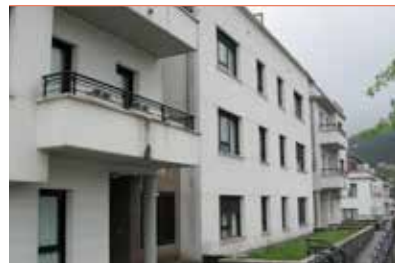
ALO-G005
MARRUTXIPI 55 - GIPUZKOA

No. homes	55
		No. public rental homes	55
		Year built	2006

FACADE: Thermal bridge issues. Other issues (leaks, detachments, condensation), but they appear to have been resolved.

PHYSICAL ACCESSIBILITY: Width of leaf on main door < 90 cm. Some unevenness on main access to entrance.

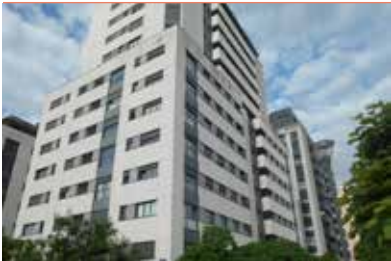
ALO-G006
RIBERAS DE LOIOLA 91 - GIPUZKOA

No. homes	91
		No. public rental homes	91
		Year built	2007

FACADE: Issues in the past (leaks, detachments), but they appear to have been resolved.

TYPE OF HEATING AND HOT WATER: Communal heating with AUGÉ self-management. LEAKO System annulled, but twin-pipe distribution maintained. Issues with hot water.

OBSERVATIONS: First pay-as-you-go installed in ALOKABIDE.

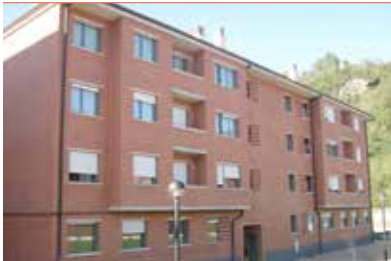
ALO-G007
TOLOSA 16 - GIPUZKOA

No. homes	16
		No. public rental homes	16
		Year built	2009

FACADE: Issues in the past (leaks), but they appear to have been resolved.

PHYSICAL ACCESSIBILITY: Details with no impact on normal use.

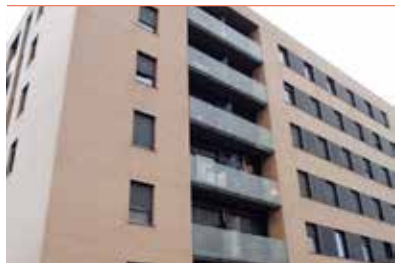
ALO-G008
ERRENTERIA 23 - GIPUZKOA

No. homes		24
	No. public rental homes		23
	Year built		2004

TYPE OF HEATING AND HOT WATER: Communal heating without AUGÉ. LEAKO System.

OBSERVATIONS: Following legal action by other entrances, repair of façade, cracks, settled by VISESA (ALOKABIDE entrance has supported the agreement).

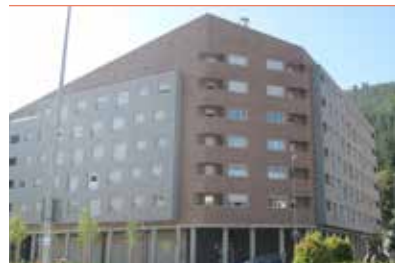
ALO-G009
ARRASATE 100 - GIPUZKOA

No. homes		100
	No. public rental homes		95
	Year built		2007

ROOF: Sloping. With recurrent issues (leaks).

FACADE: Issues in the past (detachments, cracks), but they appear to have been resolved.

TYPE OF HEATING AND HOT WATER: Communal without AUGÉ. The heating installation often leaks.

PHYSICAL ACCESSIBILITY: Details with no impact on normal use.

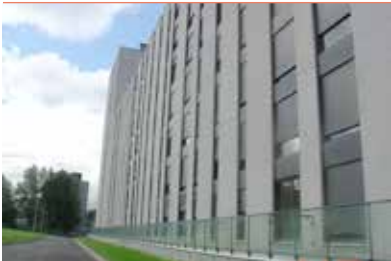
ALO-G010
IZA 48 - GIPUZKOA

No. homes	48
		No. public rental homes	44
		Year built	2008

FACADE: Issues in the past (leaks, flaking, detachment of panels), but they appear to have been resolved.

TYPE OF HEATING AND HOT WATER: Communal heating without AUGÉ. LEAKO System.

PHYSICAL ACCESSIBILITY: Details with no impact on normal use.

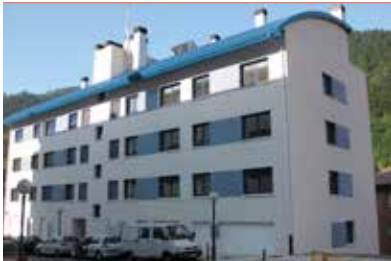
ALO-G011
SORALUCE 16 - GIPUZKOA

No. homes	16
		No. public rental homes	16
		Year built	2009

ROOF: Sloping. Issues in the past (leaks). Resolved.

PHYSICAL ACCESSIBILITY: Width of leaf on main door < 90 cm. Some unevenness on main access to entrance.

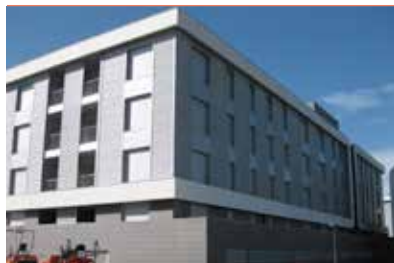
ALO-G012
MUTRIKU 75 - GIPUZKOA

No. homes	75
		No. public rental homes	75
		Year built	2011

TYPE OF HEATING AND HOT WATER: Communal without AUGÉ. Problemas con la cal del agua (provoca roturas en las tuberías).

PHYSICAL ACCESSIBILITY: Width of leaf on main door < 90 cm. Some unevenness on main access to entrance.

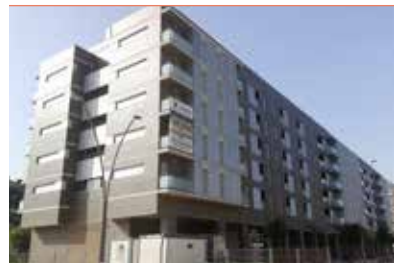
ALO-G013
PASAIA 68 - GIPUZKOA

No. homes	212
		No. public rental homes	68
		Year built	2014

PHYSICAL ACCESSIBILITY: Details with no impact on normal use.

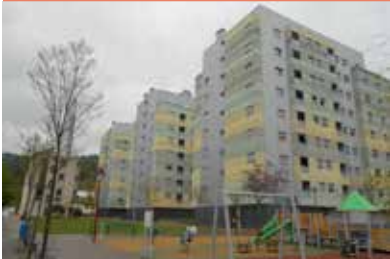
ALO-G015
ARRASATE 140 - GIPUZKOA

No. homes	140
		No. public rental homes	140
		Year built	2013

FACADE: Issues in the past (leaks), but they appear to have been resolved.

PHYSICAL ACCESSIBILITY: Details with no impact on normal use.

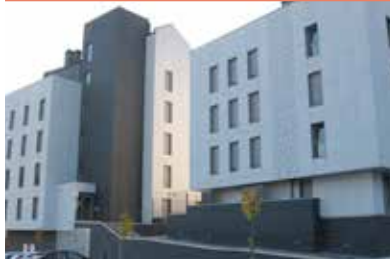
ALO-G016
BEASAIN 25 - GIPUZKOA

No. homes	25
		No. public rental homes	25
		Year built	2013

FACADE: Issues in the past (leaks), but they appear to have been resolved.

PHYSICAL ACCESSIBILITY: Details with no impact on normal use.

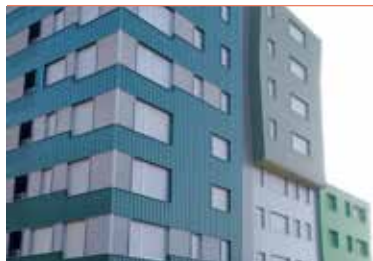
ALO-G018
HERNANI 34 - GIPUZKOA

No. homes	34
		No. public rental homes	34
		Year built	2010

ROOF: Flat. Issues in the past (leaks). Resolved.

FACADE: Issues in the past (leaks in garages), but they appear to have been resolved.

PHYSICAL ACCESSIBILITY: Width of passage through main access < 90 cm, although the door-leaf is 90 cm or more.

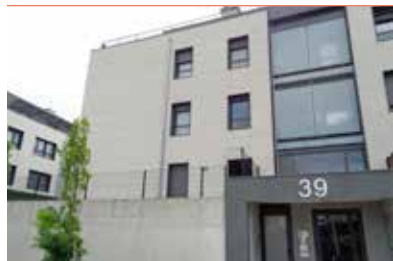
ALO-G019
IRUN 16 - GIPUZKOA

No. homes	64
		No. public rental homes	16
		Year built	2016

OBSERVATIONS: Recently assigned.

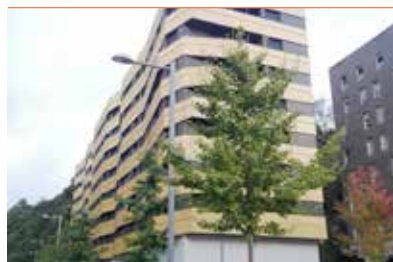
ALO-G020 MORLANS 70 - GIPUZKOA

No. homes	70
No. public rental homes	70
Year built	2019

OBSERVATIONS: Recently assigned. Aerothermal with photovoltaic, using hot air from a Trombe wall.

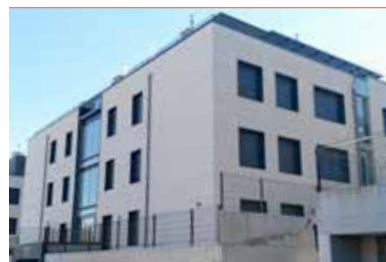
ALO-G021 IRUN 32 VS - GIPUZKOA

No. homes	32
No. public rental homes	32
Year built	2018

OBSERVATIONS: Recently assigned.

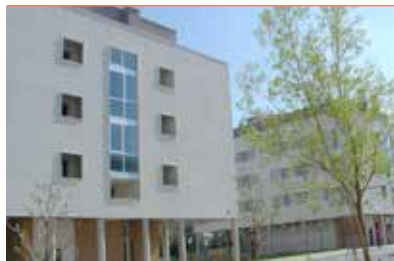
GOB-A001
ABETXUKO 106 - ARABA

No. homes	106
		No. public rental homes	106
		Year built	2005

PHYSICAL ACCESSIBILITY: Details with no impact on normal use.

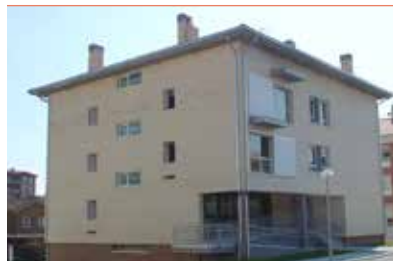
GOB-A002
AMURRIO 24 - ARABA

No. homes	24
		No. public rental homes	24
		Year built	1996

PHYSICAL ACCESSIBILITY: Width of leaf on main door < 90 cm. Some unevenness on main access to entrance.

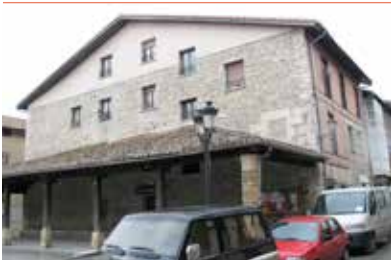
GOB-A003
SALVATIERRA 4 - ARABA

No. homes	4
		No. public rental homes	4
		Year built	1996

ROOF: Sloping. Issues in the past (leaks). Resolved.

FACADE: No major repair issues.

OBSERVATIONS: The building is in the old quarter of Salvatierra (refurbished Feb-96). An inspection was carried out and its structure revealed that it would be complicated to install a lift (therefore low priority). Any refurbishment would involve interior insulation.

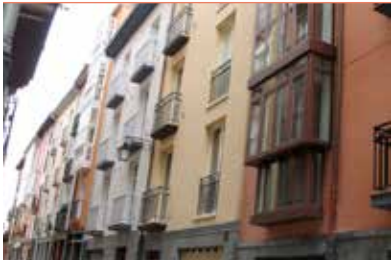
GOB-A004
VITORIA 12 - ARABA

No. homes	12
		No. public rental homes	12
		Year built	2006

ROOF: Sloping. Issues in the past (leaks). Resolved.

OBSERVATIONS: Going refurbishment. Scheduled installation of lifts within the PCTI's nZEB Strategic Initiative, but no plans for photovoltaic. All the individual boilers to be replaced by wall-mounted condensation boilers.

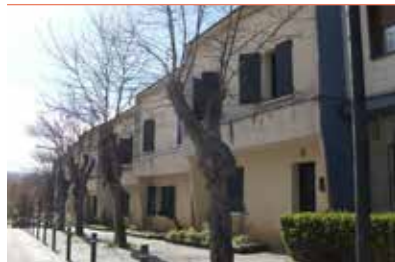
GOB-A012
ABETXUKO 7 - ARABA

No. homes	7
		No. public rental homes	7
		Year built	1994

FACADE: No major repair issues.

OBSERVATIONS: No options for installing a lift due to the following issues: two abutting two-storey blocks of flats (no entrances). Some of the facades have recently been painted.

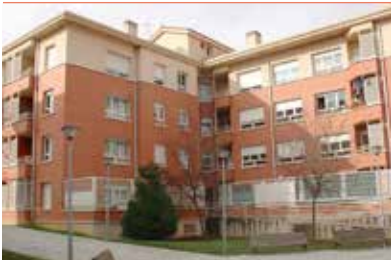
GOB-A014
VITORIA 99 - ARABA

No. homes	99
		No. public rental homes	99
		Year built	1999

PHYSICAL ACCESSIBILITY: Width of leaf on main door < 90 cm. Some unevenness on main access to entrance.

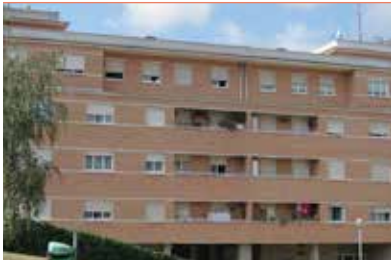
GOB-A015
LLODIO 32 - ARABA

No. homes	32
		No. public rental homes	32
		Year built	2001

PHYSICAL ACCESSIBILITY: Details with no impact on normal use.

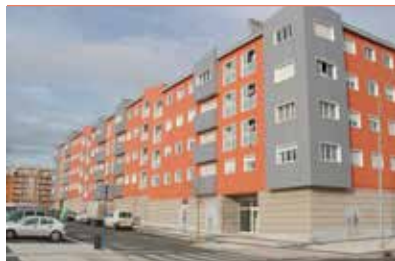
GOB-A017
VITORIA 104 - ARABA

No. homes	104
		No. public rental homes	101
		Year built	2002

ROOF: Sloping. With issues (leaks, broken tiles), needs attention.

FACADE: Issues in the past (leaks through ventilated façade), but they appear to have been resolved.

PHYSICAL ACCESSIBILITY: Width of leaf on main door < 90 cm. Some unevenness on main access to entrance.

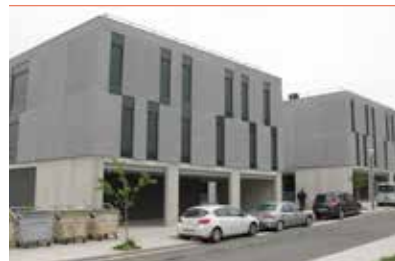
GOB-A023
LEGUTIANO 16 - ARABA

No. homes	16
		No. public rental homes	16
		Year built	2013

PHYSICAL ACCESSIBILITY: Details with no impact on normal use.

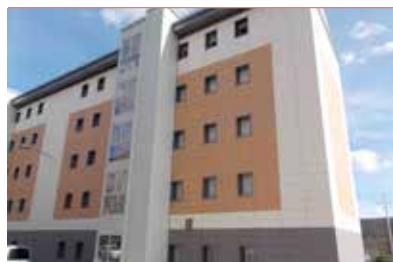
GOB-A025
SAN JOSE 12 - ARABA

No. homes	10
No. public rental homes	8
Year built	2013

OBSERVATIONS: Recently renovated building in which ALOKABIDE has acquired several housing units, although they need sundry alterations.

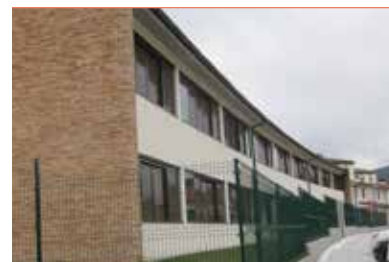
GOB-A21A
IRUÑA DE OCA 12 - ARABA

No. homes	12
No. public rental homes	12
Year built	2014

PHYSICAL ACCESSIBILITY: Details with no impact on normal use.

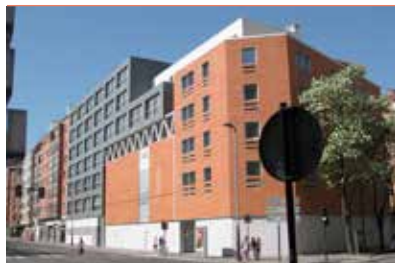
GOB-A22A
CORONACIÓN 79 - ARABA

No. homes	79
		No. public rental homes	79
		Year built	2015

FACADE: Issues in the past (leaks), but they appear to have been resolved.

TYPE OF HEATING AND HOT WATER: Communal heating without AUGÉ. Twin-pipe system, but not Leako.

OBSERVATIONS: Project for turning street-level premises into homes and communal areas.

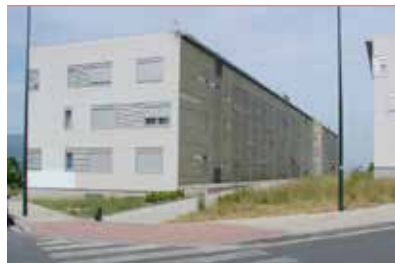
GOB-B001
BILBAO 57 - BIZKAIA

No. homes	57
		No. public rental homes	34
		Year built	2004

ROOF: Sloping. With recurrent issues (leaks).

PHYSICAL ACCESSIBILITY: Details with no impact on normal use.

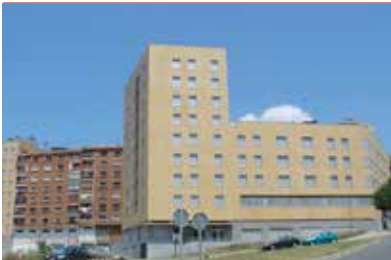
GOB-B002
BILBAO 58 - BIZKAIA

No. homes	58
		No. public rental homes	57
		Year built	2005

ROOF: Sloping. Issues in the past (leaks). Resolved.

FACADE: With issues (Ventilated façade damaged, leaks).

PHYSICAL ACCESSIBILITY: Details with no impact on normal use.

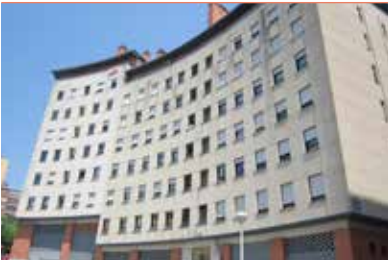
GOB-B003
BILBAO 140 - BIZKAIA

No. homes	140
		No. public rental homes	108
		Year built	2006

ROOF: Sloping. Issues in the past (leaks). Resolved.

OBSERVATIONS: The housing units in one entrance belong to the local council.

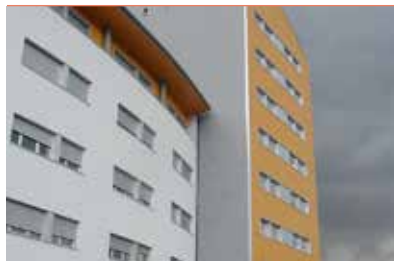
GOB-B004
ARRIGORRIAGA 42 - BIZKAIA

No. homes		42
	No. public rental homes		42
	Year built		2005

ROOF: Flat.Issues in the past (loose roof tiles and leaks). Resolved.

FACADE: With issues (leaks).

PHYSICAL ACCESSIBILITY: Details with no impact on normal use.

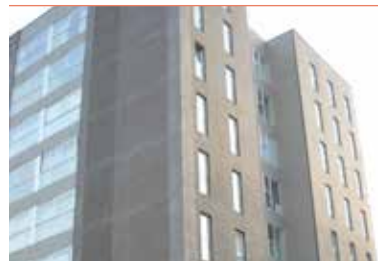
GOB-B005
TXURDINAGA 32 - BIZKAIA

No. homes		32
	No. public rental homes		32
	Year built		2013

ROOF: Flat. Issues in the past (leaks). Resolved.

FACADE: With issues (leaks, water coming through windows, low rating).

PHYSICAL ACCESSIBILITY: Details with no impact on normal use.

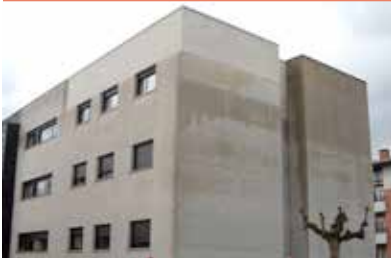
GOB-B006
BERANGO 12 - BIZKAIA

No. homes	12
		No. public rental homes	11
		Year built	2004

ROOF: Flat. Issues in the past (leaks). Resolved.

PHYSICAL ACCESSIBILITY: Width of passage through main access < 90 cm, although the door-leaf is 90 cm or more.

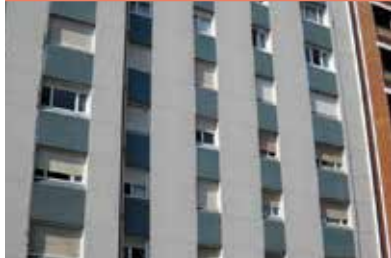
GOB-B007
EL BURGO 48 - BIZKAIA

No. homes	48
		No. public rental homes	24
		Year built	1982

OBSERVATIONS: Although all 4 blocks have a lift, the presence of steps in the access to them and the nature of the cabins themselves, which are significantly smaller than those required by the regulations- are reasons enough for making it a priority in terms of accessibility.

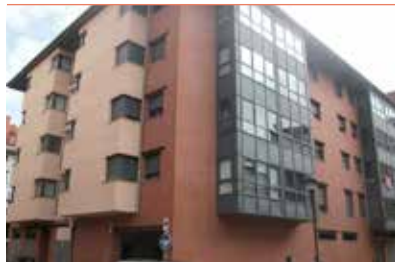
GOB-B010
AMOREBIETA 32 - BIZKAIA

No. homes	32
		No. public rental homes	32
		Year built	2004

FACADE: No major repair issues.

PHYSICAL ACCESSIBILITY: Details with no impact on normal use.

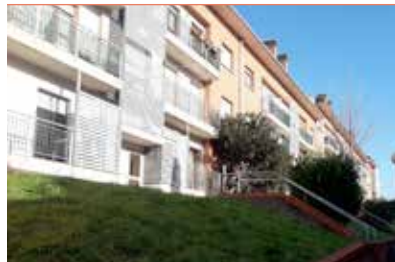
GOB-B014
PORTUGALETE 66 - BIZKAIA

No. homes	66
		No. public rental homes	58
		Year built	1998

FACADE: No major repair issues.

OBSERVATIONS: Issues with the possible siting of the lifts on public land, although it is a major priority, the cost is very high.

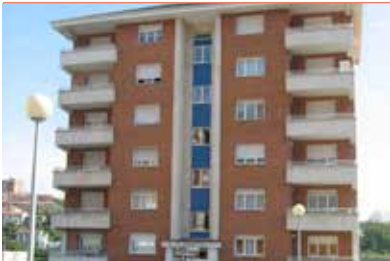
GOB-B017
TRAPAGARAN 13 - BIZKAIA

No. homes	13
		No. public rental homes	13
		Year built	2001

FACADE: With issues (leaks).

PHYSICAL ACCESSIBILITY: Slope with 1-2 steps on access to building. Width of the door-leaf on the main entrance less than 80 cm. Main corridors <150 cm.

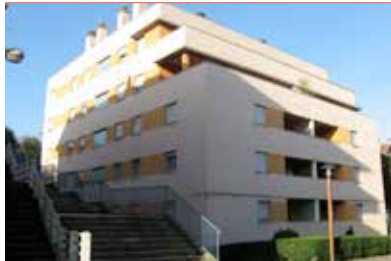
GOB-B018
PLENTZIA 20 - BIZKAIA

No. homes	20
		No. public rental homes	20
		Year built	2002

ROOF: Flat. Issues in the past (leaks). Resolved.

FACADE: Issues in the past (leaks), but they appear to have been resolved.

PHYSICAL ACCESSIBILITY: Width of leaf on main door < 90 cm. Some unevenness on main access to entrance.

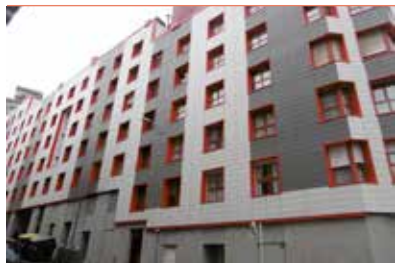
GOB-B024
SESTAO 35 - BIZKAIA

No. homes		35
	No. public rental homes		22
	Year built		2000

TYPE OF HEATING AND HOT WATER: Individual boilers.The Individual boilers are to be replaced during the refurbishment by a connection to a communal biomass system through a Tifell panel on the building and a pay-as-you-go tablet.

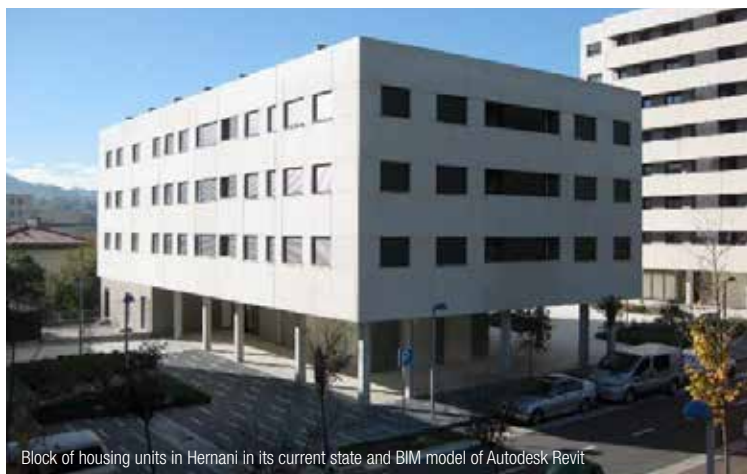
Block of housing units in Hernani in its current state and BIM model of Autodesk Revit

- CLASS 1: building with lift, energy rating A/B. Model Hernani 20.
- CLASS 2: building with lift, energy rating C/D. Model Zabalgana 155.
- CLASS 3: building with lift, energy rating E/F/G.
- CLASS 4: building without lift, energy rating A/B.
- CLASS 5: building without lift, energy rating C/D.
- CLASS 6: building without lift, energy rating E/F/G.

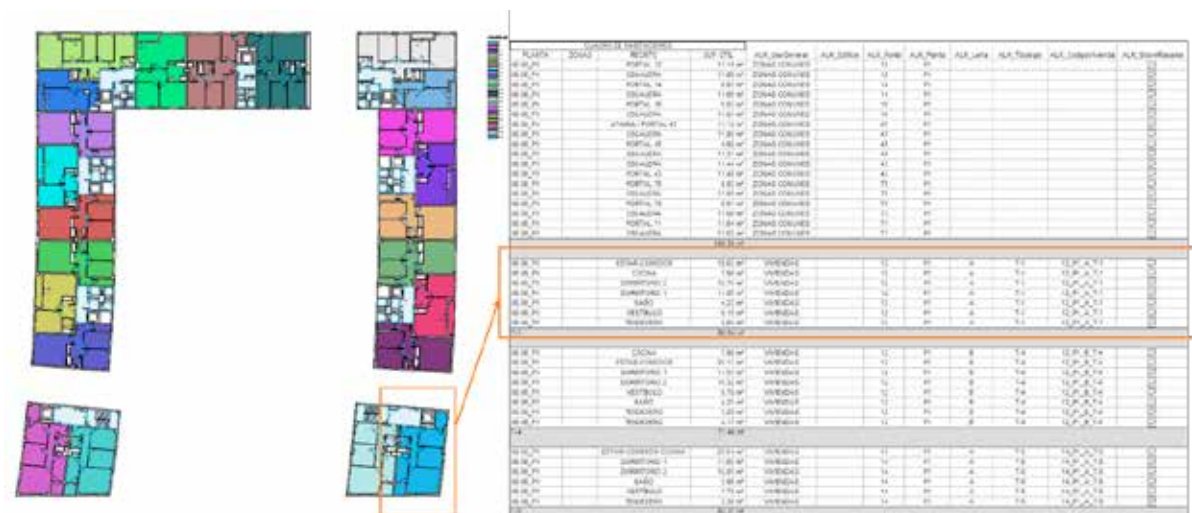
Colour chart for representative buildings and their relationship with the data in tables according to entrances and zoning.
